# HOME INSPECTION REPORT

*John Curtin Home Inspector LLC*

*4 Junate Drive # 222  
Jupiter, FL 33469*

**Date & time:** April 18, 2017

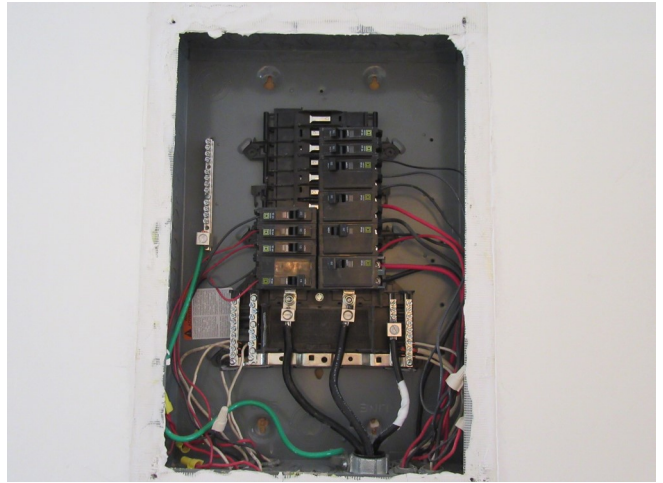
**Electric panel located in the hall**

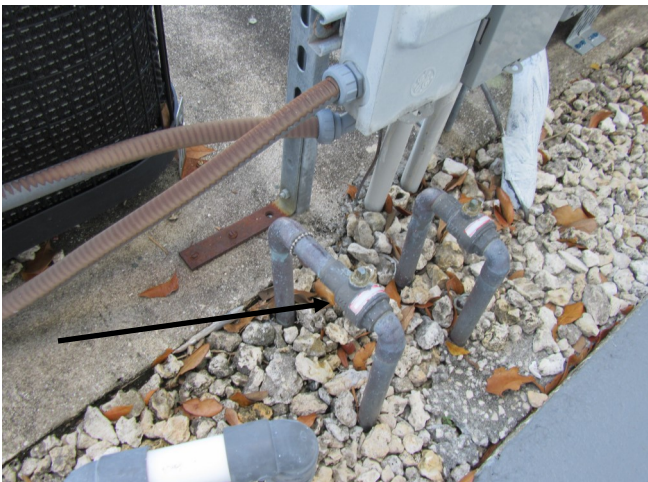
**Water shutoff located by the air compressor**

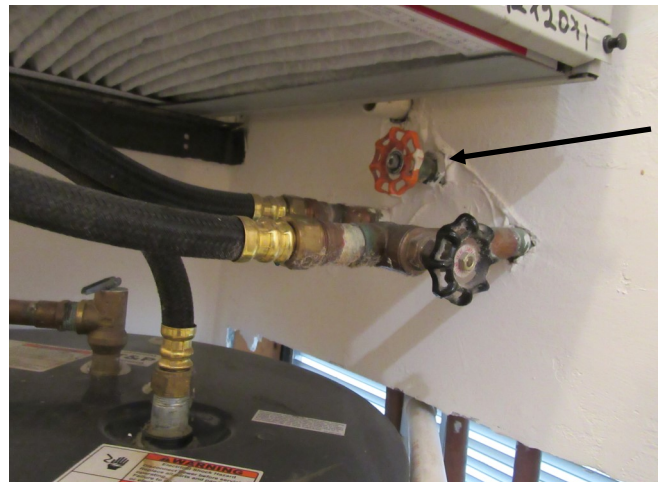
**Water shutoff located above the water heater.**

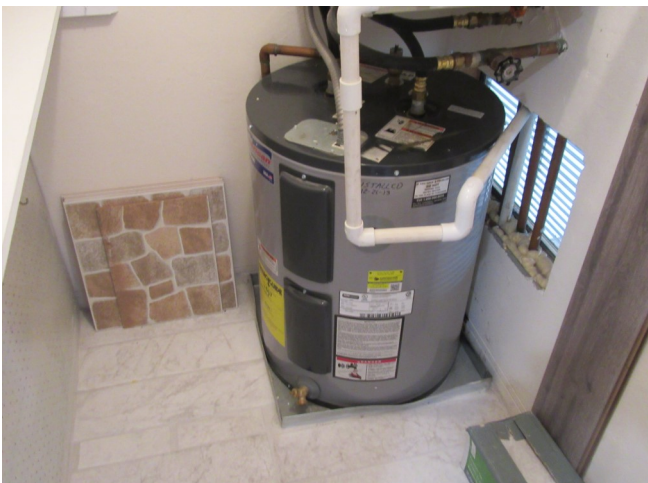
**Water heater located in the kitchen closet**

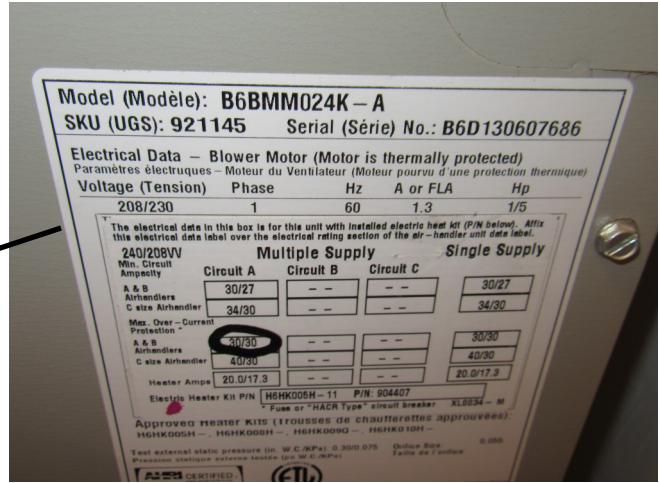
Air handler located in the kitchen closet

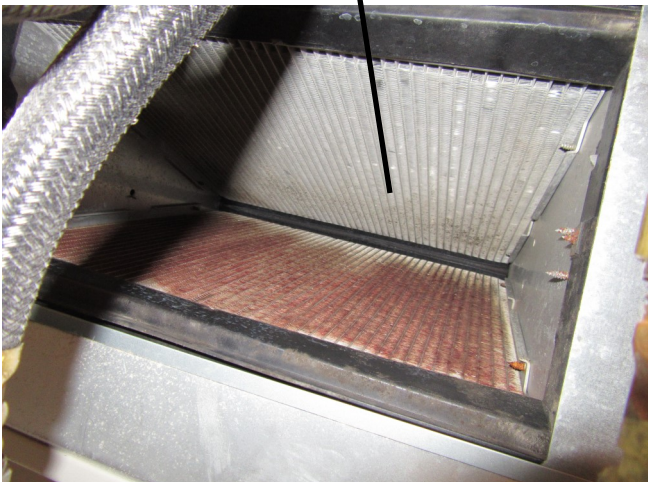
The air handler coils were clean

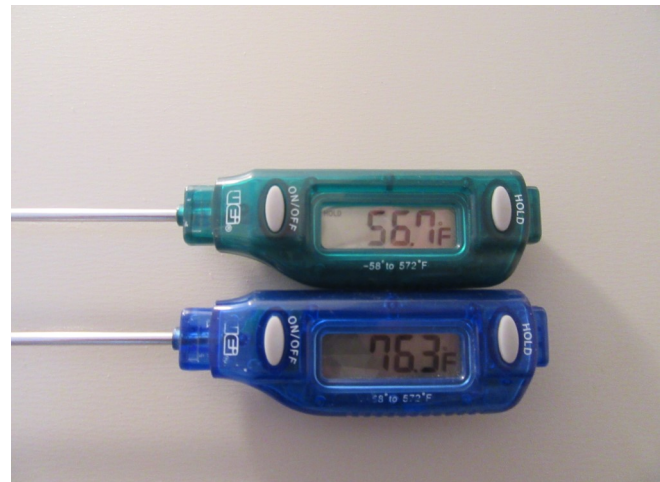
The temperature differential was 20 deg.

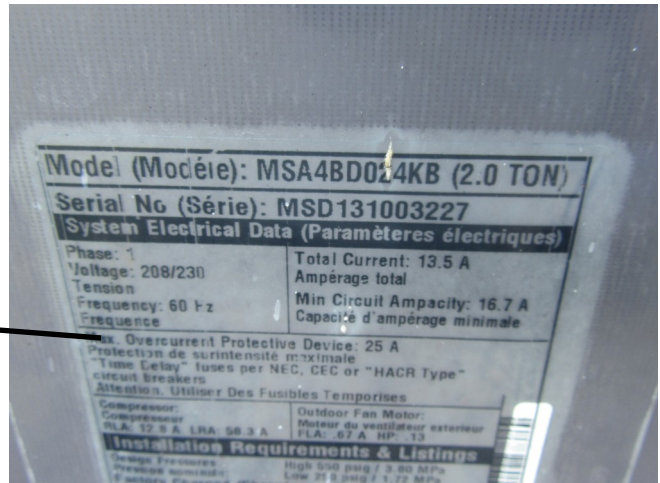
Air condenser located in the parking area

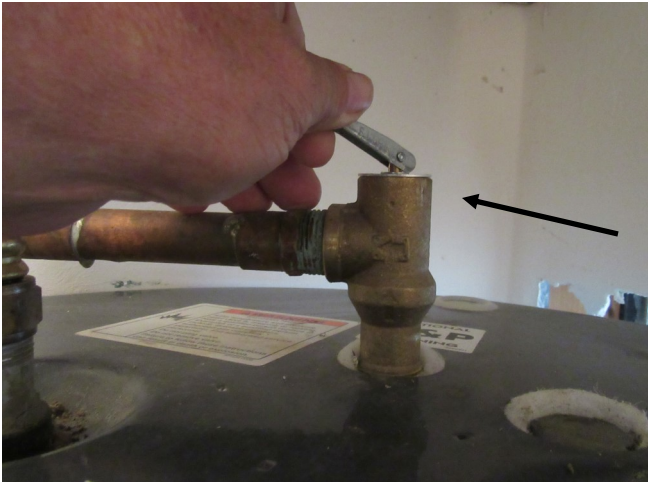
Water heater pressure relief valve		X			<b>*The pressure relief valve on the water heater <u>did not release</u> when tested. It is not uncommon for valves which are more than a few years old to stick due to our mineral rich water. The valve is not forced as it may not reseal causing a leak which necessitates the replacement of the valve. Manufactures suggest that the valves be tested regularly to prevent this condition and typically they are not. For more information see <a href="https://jchomeinspector.com/homeowner-tips/50-water-heater-pressure-relief-valve">https://jchomeinspector.com/homeowner-tips/50-water-heater-pressure-relief-valve</a></b>
House hold supply lines	X				In good condition where visible. Due to the mineral rich water in Florida, in homes 5 years old or more, it can be anticipated that interior valves for sinks & toilets may be difficult to operate. And may need to be changed if faucets are replaced.

**The pressure relief valve on the water heater did not release when tested.**

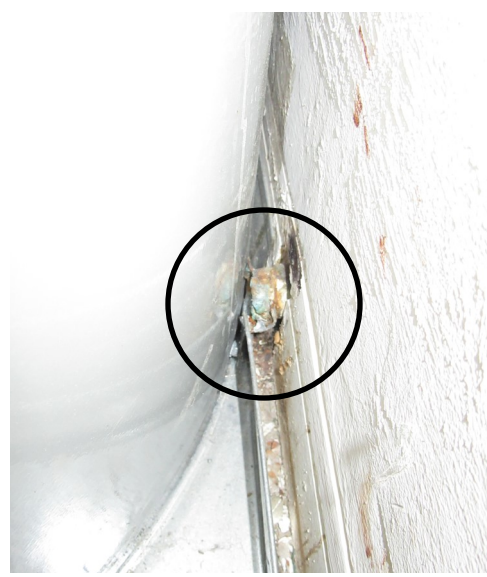
**The pan under the hot water heater has been replaced. Where the drain line connects it is not properly secured and sealed. If the heater were to leak into the pan the pan would over flow when reaching approximately 1/2" of water.**

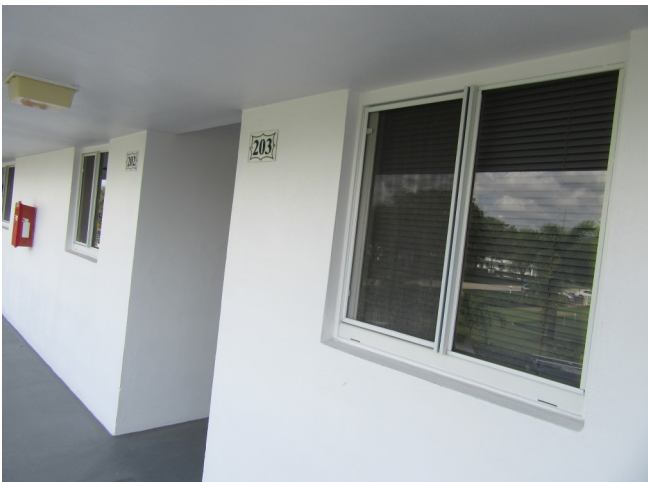
**West side windows are Miami Dade impact rated as determined by etching on glass**

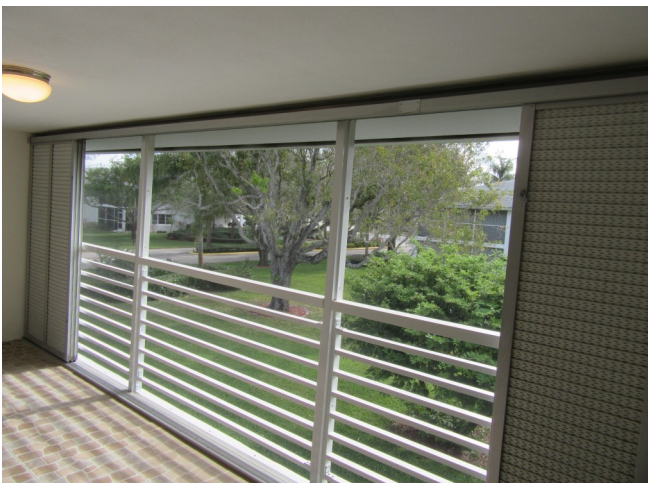
**Non rated sun shutters on the east patio**
