HOME INSPECTION REPORT

John Curtin Home Inspector LLC

*1234 Neighborhood Circle
Any Town, FL*

Date & time: March 13, 2017

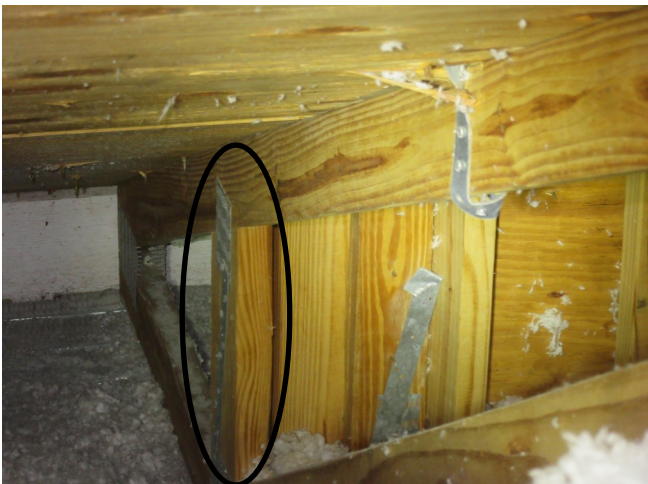
Single wrapped metal straps NOT wrapping the top of the truss used to secure the roof rafters to the CBS walls.

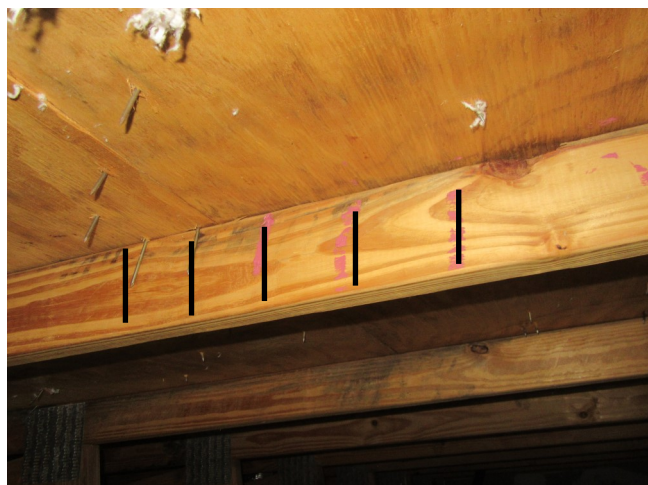
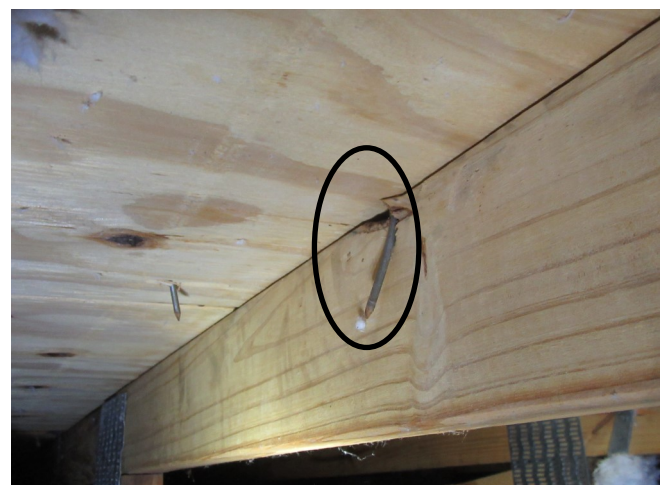
Roof nailing pattern of 8pn nails installed 6" oc center in the field and 6" oc center on the edge is determined with the use of a Zircom MT6 metal detector.

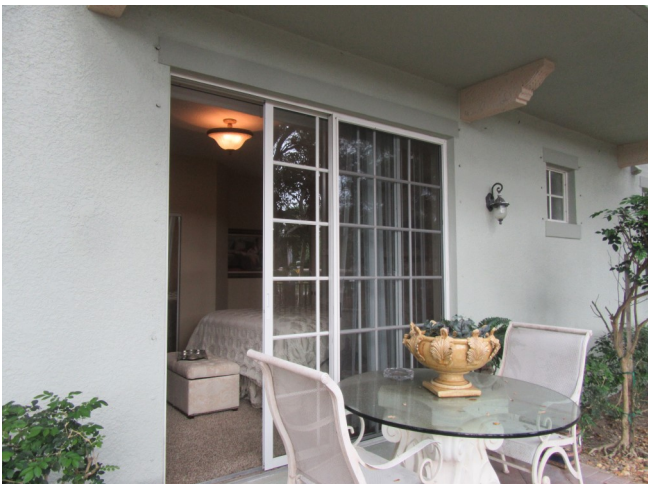
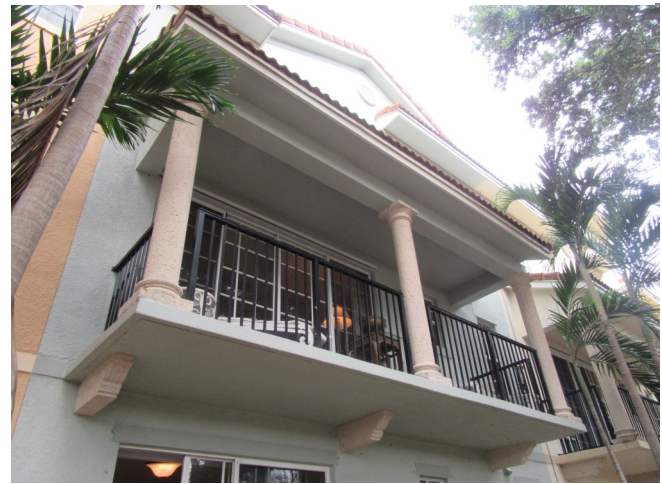
Miami-Dade impact rated windows and doors on the second and third floors and corrugated Miami Dade rated shutters for the first floor openings stored in the garage.

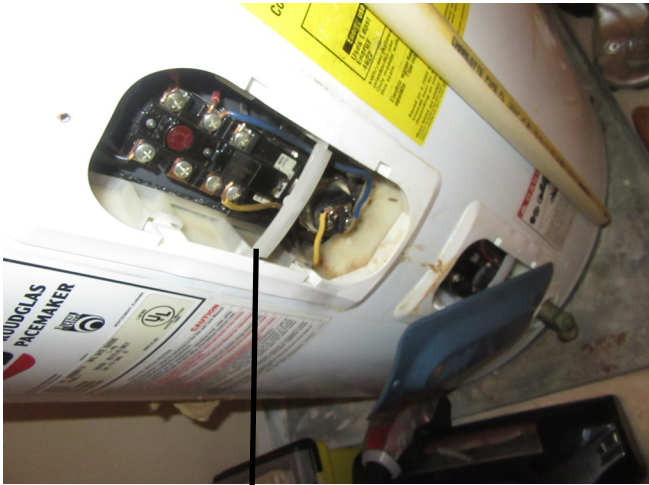
On the water heater case the exterior covers for the two thermostats have been removed and not reinstalled. No functional defect is noted but it is observed the water temperature is 147° which is well above the normal and considered safe temperature.

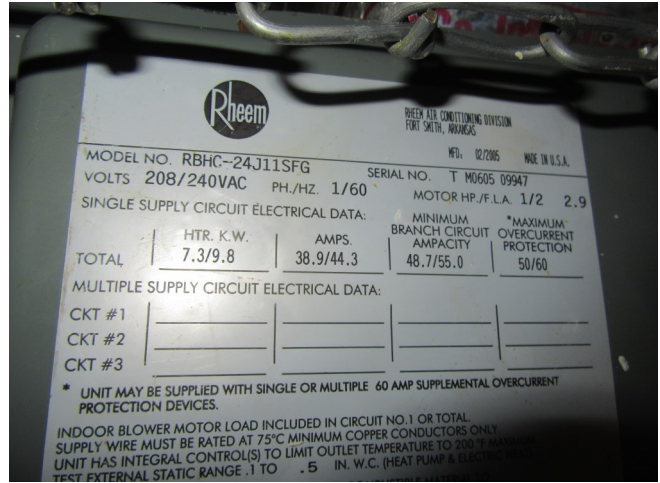
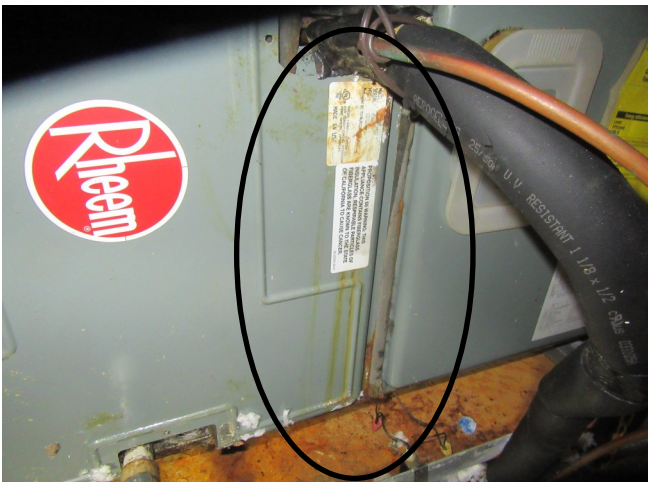
On the exterior of the air handler case, where the coolant piping connects to the coil, dry rust stains were noted running down the front of the case. There was also a noticeable quantity of dry rust in the bottom of the emergency backup overflow condensation pan under the unit.

COMPONENT	S	A	N	I	OBSERVATIONS
					Air conditioning equipment typically lasts 12 –16 years. Repair & maintenance should be expected on equipment reaching this age. Budgeting for replacement should be considered even of no defects are noted. Proximity to salt water will greatly decrease the life of external components.
Air handler		X			On the exterior of the air handler case, where the coolant piping connects to the coil, dry rust stains were noted running down the front of the case. There was also a noticeable quantity of dry rust in the bottom of the emergency backup overflow condensation pan under the unit. This indicates a past or present concern. It should be determined if and what repairs were made if any.
Handler coil		X			*The handler coils were not inspected because the unit would have needed to be disassembled. Due to the nature of the staining noticed on the air handler, in the area of the coils, it is suggested they be reviewed when the handler is serviced.

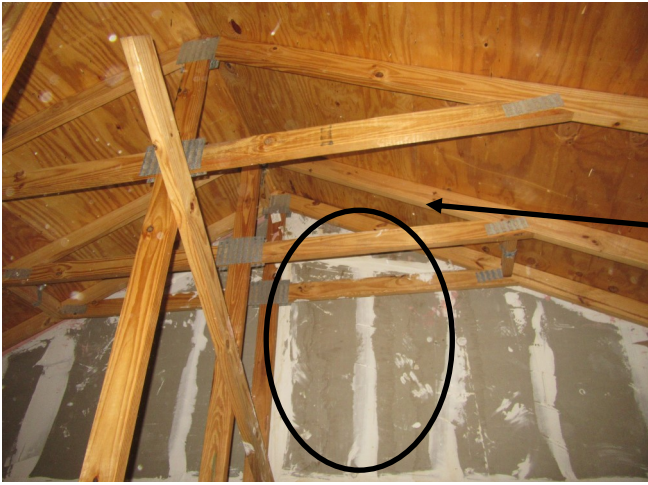
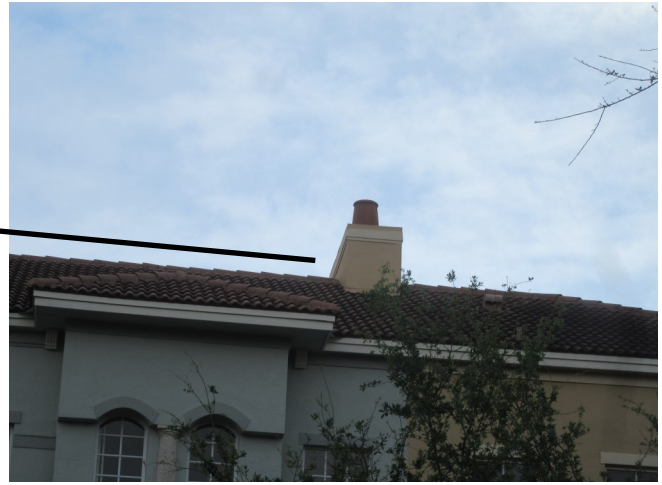
In the third floor master bedroom ceiling above the bed left side when facing it there is a water stain. In the attic above this area there is some staining on the fire rated sheetrock on the wall between the two units. It is thought there is a leak at the chimney of the neighboring unit which is in the same location. Due to the roof elevation and location the roof could not be physically and visually inspected.

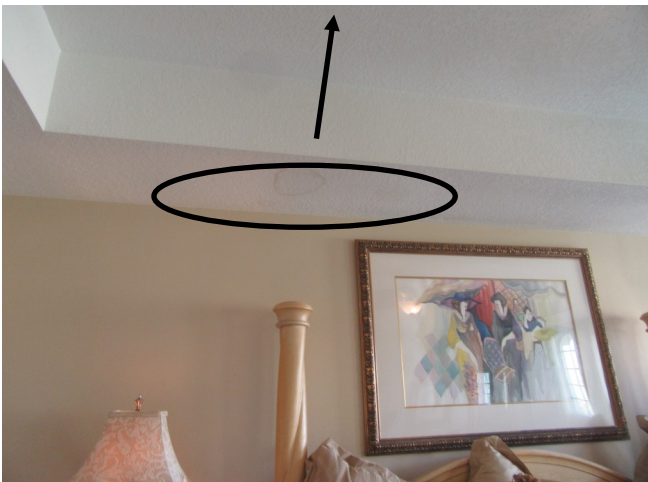
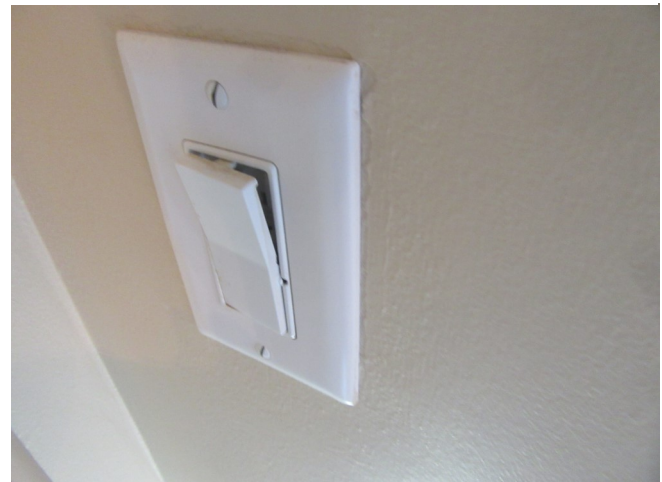
At a number of locations approximately 10 wall switches were noted to have their rockers (push buttons) coming loose..

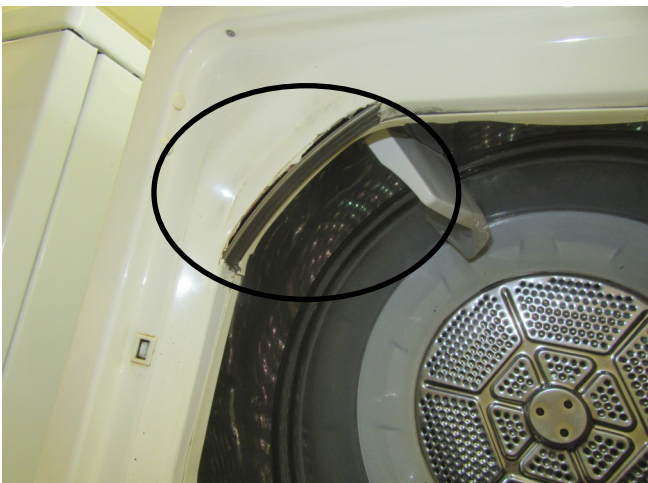
COMPONENT	S	A	N	I	OBSERVATIONS
Washing machine	X				GE brand, manufactured February 2014, with high pressure hoses. Only the normal cycle is tested.
Dryer & venting		X			GE brand, original, electric, with foil exhaust hose. The dryer vent line should be checked annually and cleaned if necessary. *The dryers clothes drum appears to be out of alignment and has cut through the unit's casing on the interior of the door to the unit. Some resting and paint chipping is noted on the top of the dryer unit.
Washer/Dryer combo		X			GE brand, original, with high pressure hoses. *The third floor washing machine was noted to leak during initial operation. The unit was stopped and the valves were turned off. The combination dryer in the unit was noted to squeak loudly when operating and a burning smell was noted indicate paying the drive belt is worn.
Cabinets and slop sink	X				Both noted

The dryers clothes drum appears to be out of alignment and has cut through the unit's casing on the interior of the door to the unit. Some resting and paint chipping is noted on the top of the dryer unit.

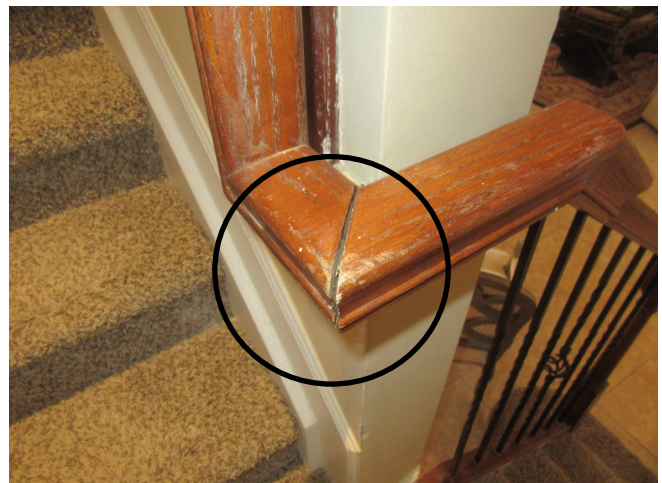
Some separation is noted at one of the stairs handrail seams.
