## 4-Point Insurance Inspection Report

Date Inspected: February 2, 2016 Inspected by: John Curtin Home Inspector, LLC (John Curtin)

Address: 123 Pleasant Street City: Tequesta State: FL Zip: 33469

Year Built: 1959 Type of home: Single family Type of Construction: CBS Number of Stories: 1

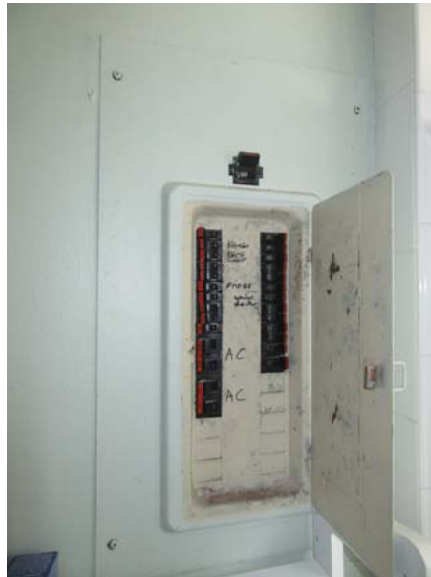
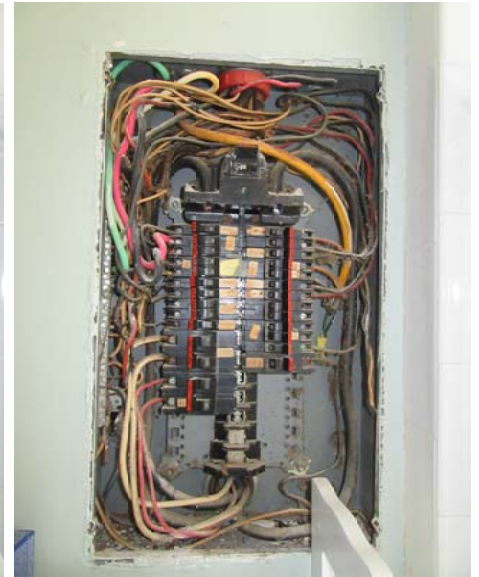
**Federal Pacific brand electric panel with a 150 amp main breaker located in the hall bathroom. No tampering was noted.**

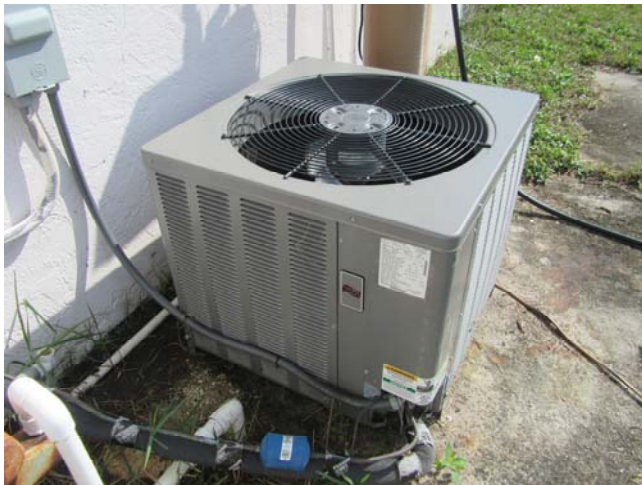
**Ruud brand air condenser, manufactured 3/2014, 3 ton, located in the rear of the house.**

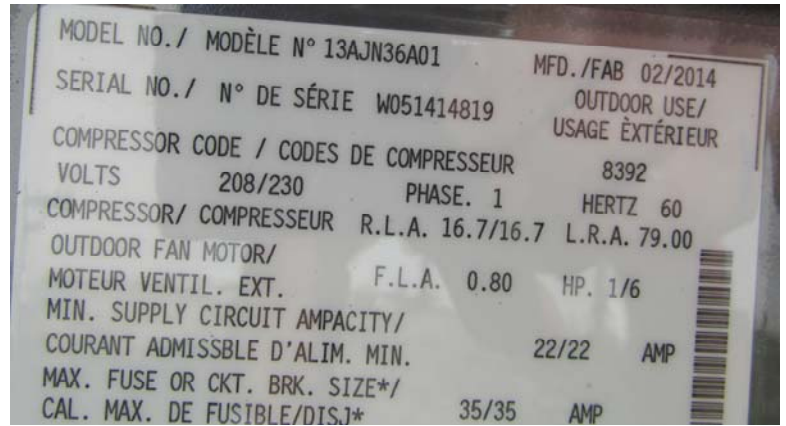
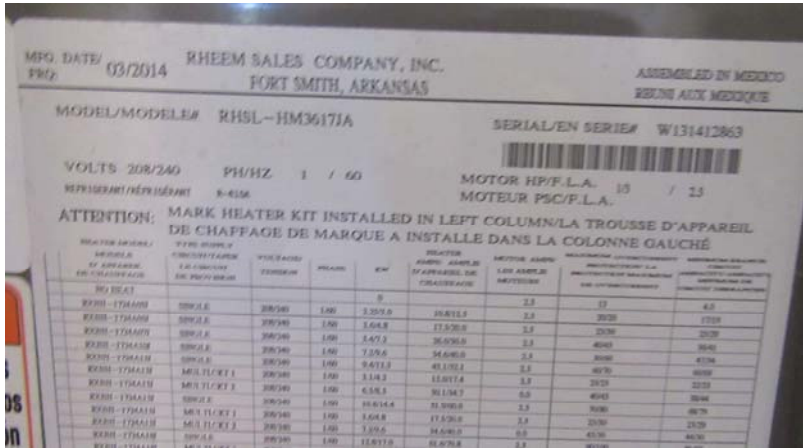
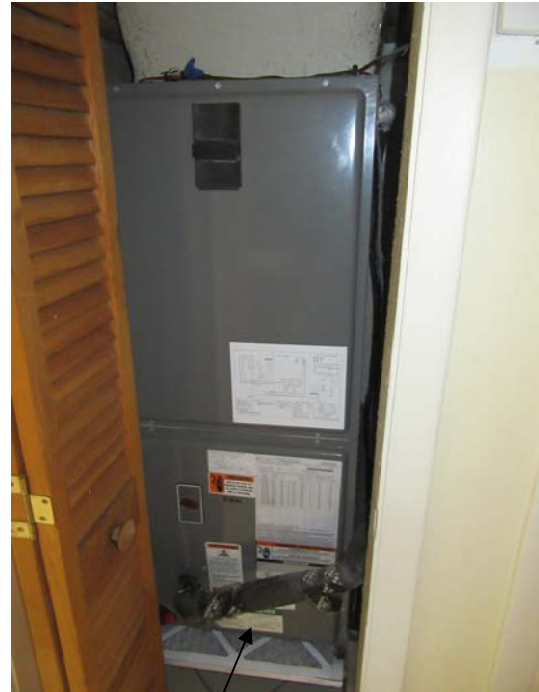
**Ruud brand air handler located in the hall closet, manufactured 2/2014.**

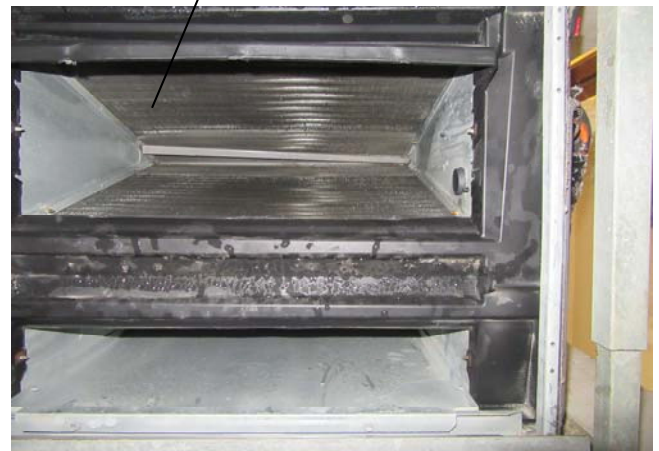
**The air handler coils were clean.**

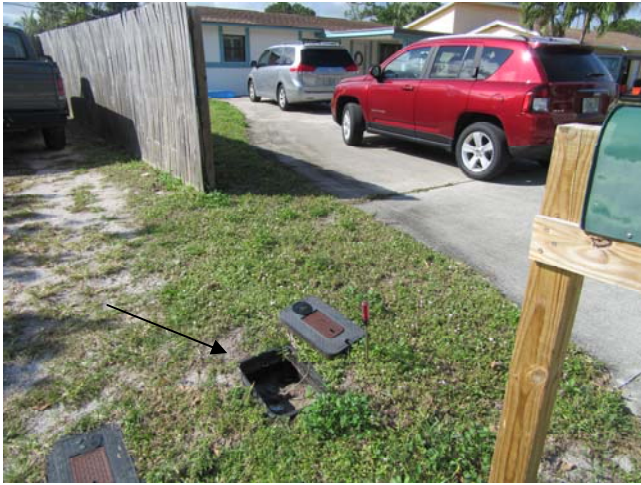
**Water meter on the front south property line.**

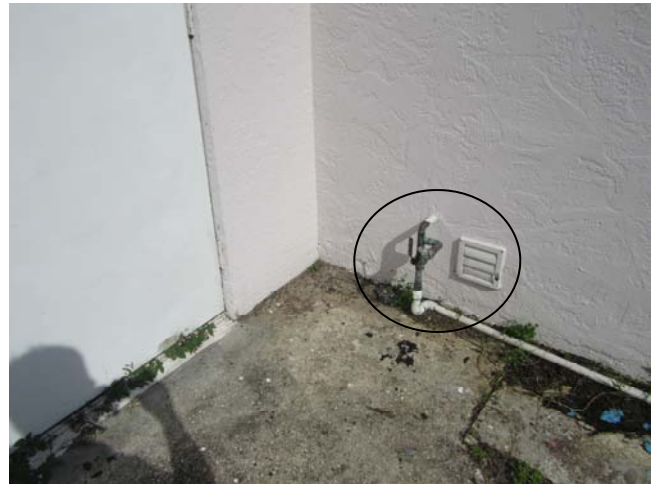
**Main water shutoff valve located on the rear of the house.**

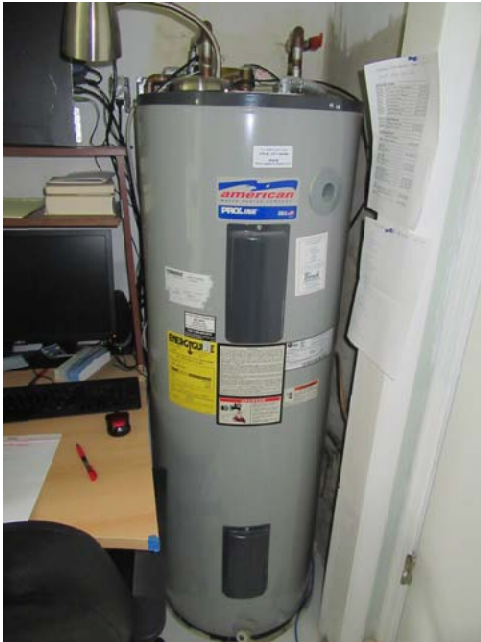
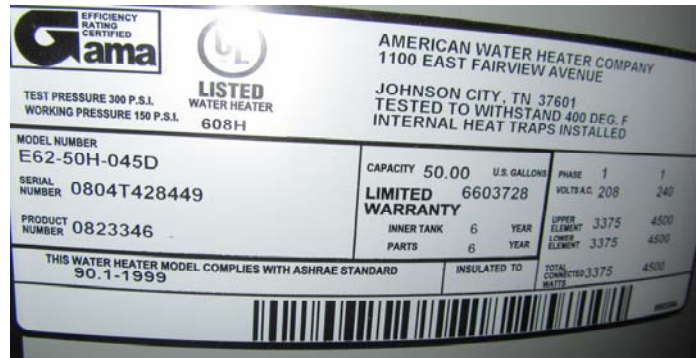
**American brand heater located in the hall bath, manufactured 2008, 50 gallons.**

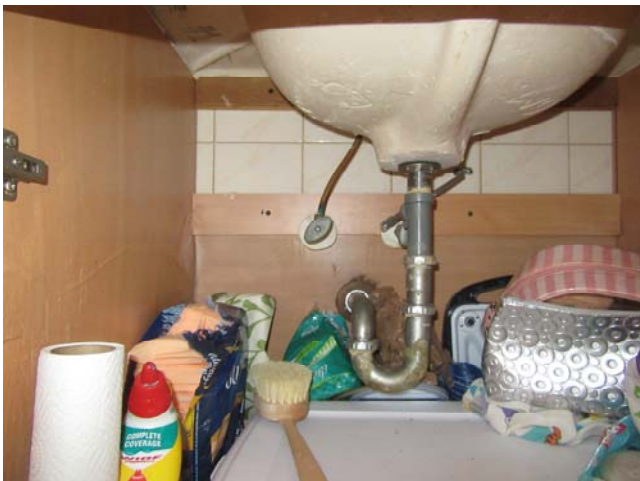
**View under typical bath sink.**

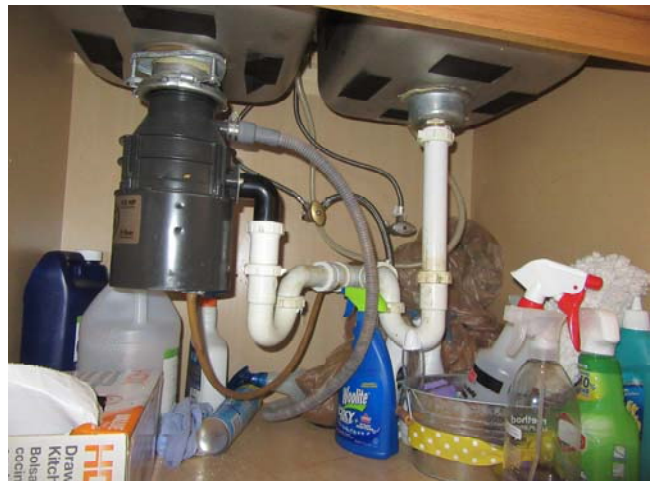
**View under kitchen sink.**

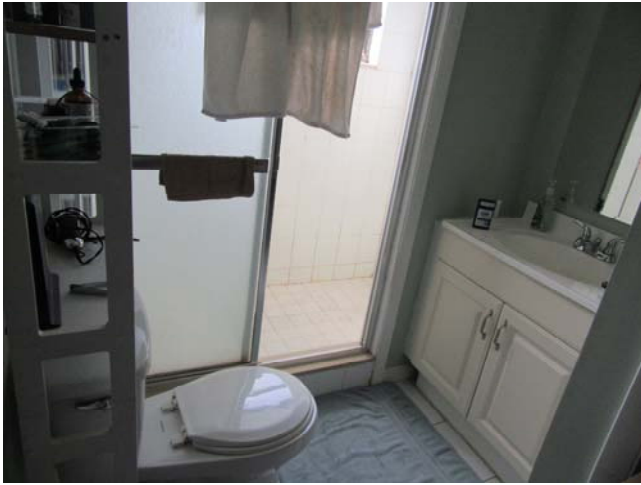
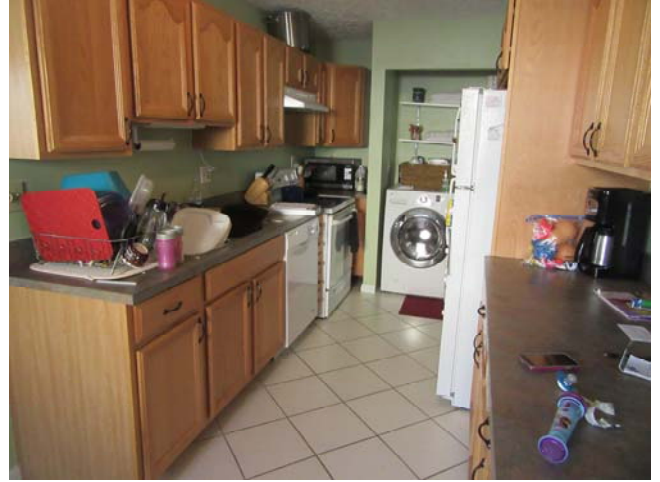
**Views of remodeled baths and kitchen.**

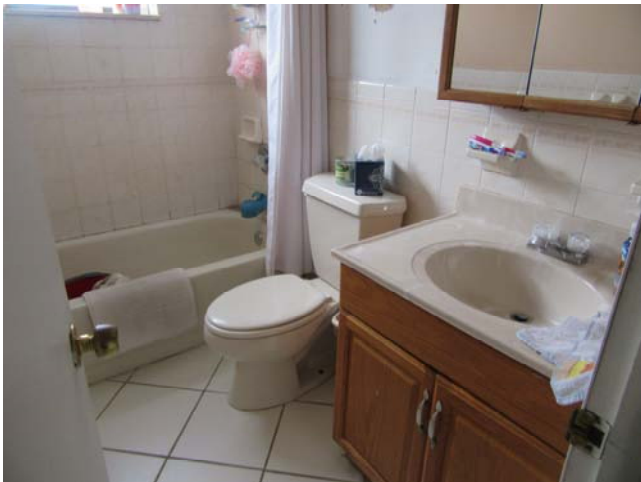
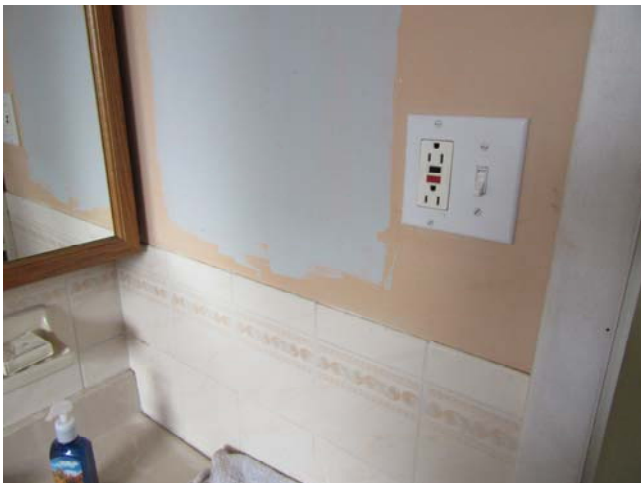
**Bath outlets are GFCI protected.**

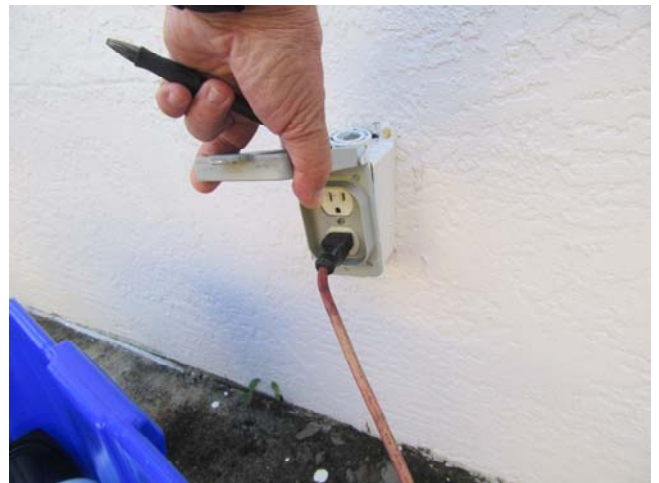
**Kitchen and exterior outlets are not GFCI protected.**
