HOME INSPECTION REPORT

John Curtin Home Inspector LLC

*1234 Neighborhood Circle
Any Town, FL*

Date & time: March 13, 2017

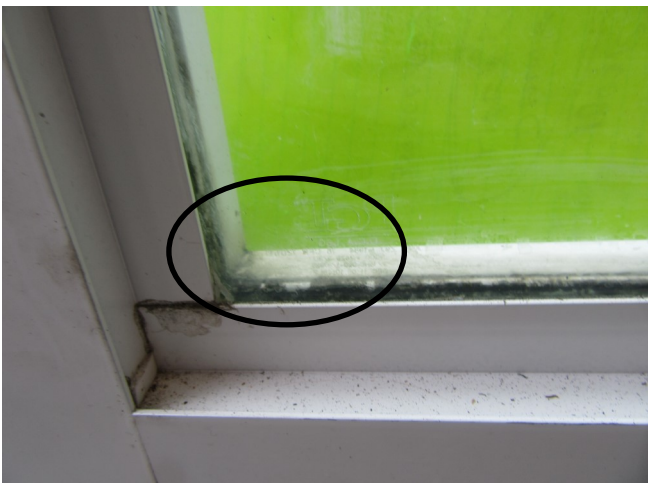
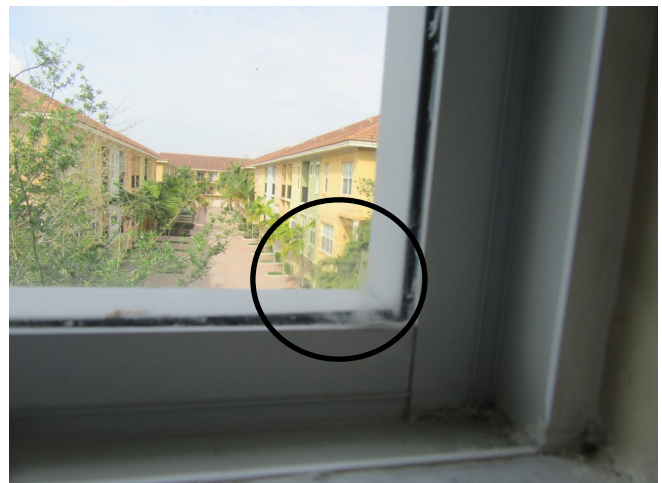
Miami-Dade impact rated windows and doors on the second and third floors and corrugated Miami Dade rated shutters for the first floor openings stored in the garage.

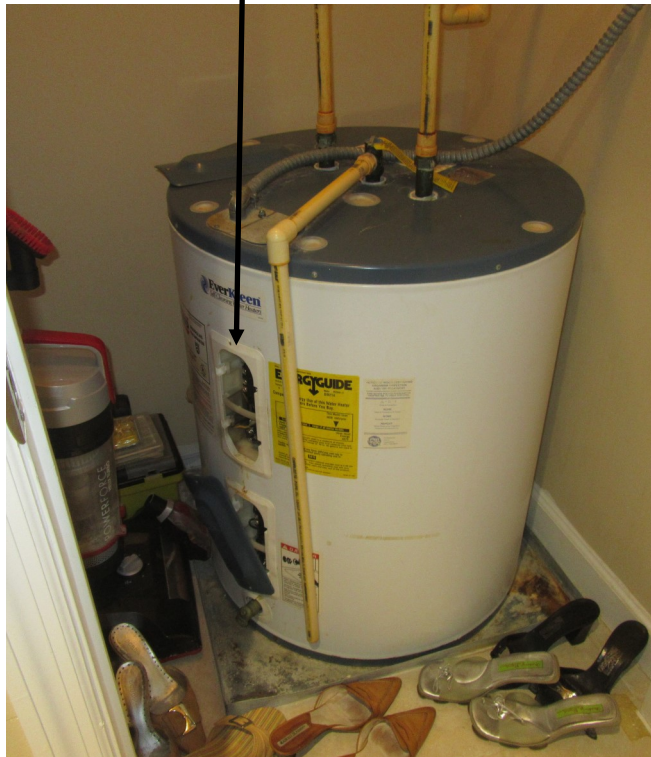
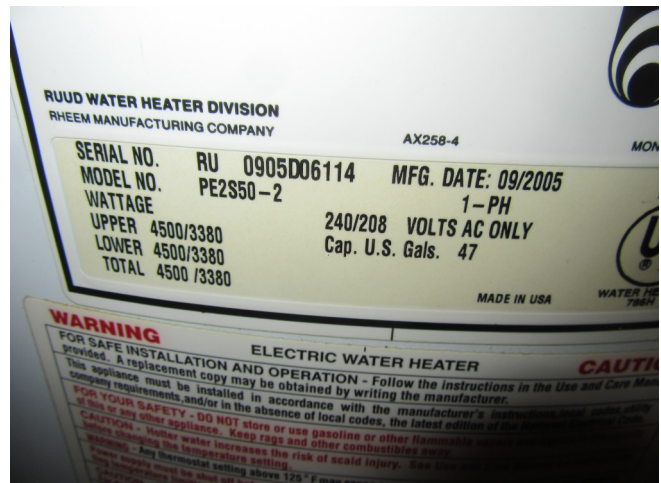
Water heater located in the 1st floor closet under the stairs

On the water heater case the exterior covers for the two thermostats have been removed and not reinstalled. No functional defect is noted but it is observed the water temperature is 147° which is well above the normal and considered safe temperature.
