## 4-Point Insurance Inspection Report

Date Inspected: February 2, 2016 Inspected by: John Curtin Home Inspector, LLC (John Curtin)

Address: 123 Pleasant Street City: Tequesta State: FL Zip: 33469

Year Built: 1959 Type of home: Single family Type of Construction: CBS Number of Stories: 1

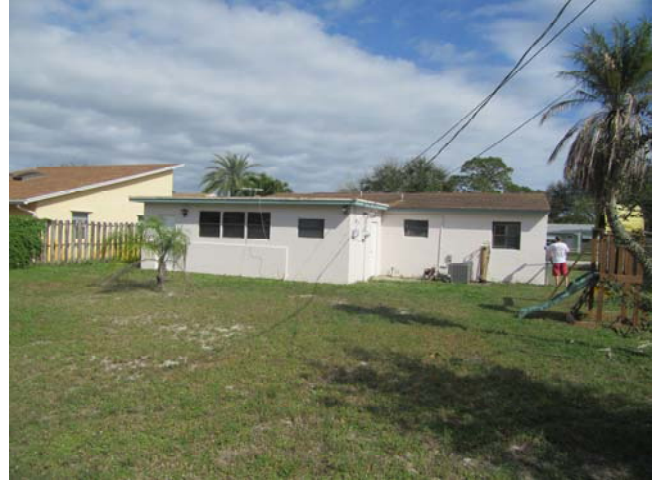
Comments: No leaks noted. A repair is noted on the front south corner. It appears proper.

**Roof permitted October 22, 1993 Pmt# 93100444**
