What is a Wind Mitigation Report? 561-406-3013

What is a wind mitigation report?

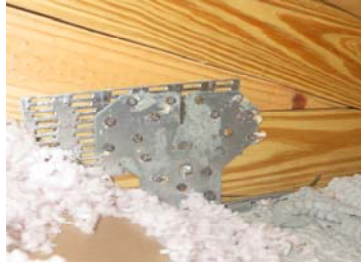
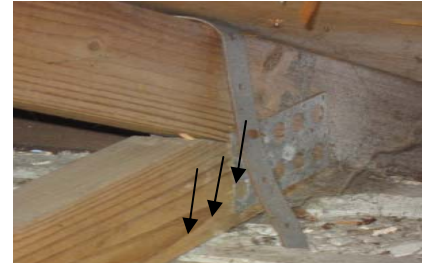
4. **Roof to Wall Attachment:** The roof truss to wall attachment will be documented with pictures. **Single wrapped straps with proper nailing will receive the greatest credit with clips receiving a lesser credit.**

Single Wraps: A strap that wraps the top of the truss and has a minimum of 2 nails on one side and 1 nail on the other side

Clips: A strap that does not wrap the top of the truss or a metal plate that has a minimum of 3 nails securing it to the truss.

Toe Nails: A roof connection that does not meet the minimum requirements for a Wrap or a Clip.
